**SURFACE FRICTION STUDY OF ARIZONA HIGHWAYS**  
**FINAL REPORT**

1. Report No.  Report No. 3	2. Government Accession No.	3. Recipient's Catalog No.	
4. Title and Subtitle  SURFACE FRICTION STUDY OF ARIZONA HIGHWAYS		5. Report Date  July 1972

6. Performing Organization Code	
7. Author(s) John C. Burns Rowan J. Peters		8. Performing Organization Report No.	
9. Performing Organization Name and Address  Materials Division (Research) 1745 West Madison Phoenix, Arizona 85007		10. Work Unit No.

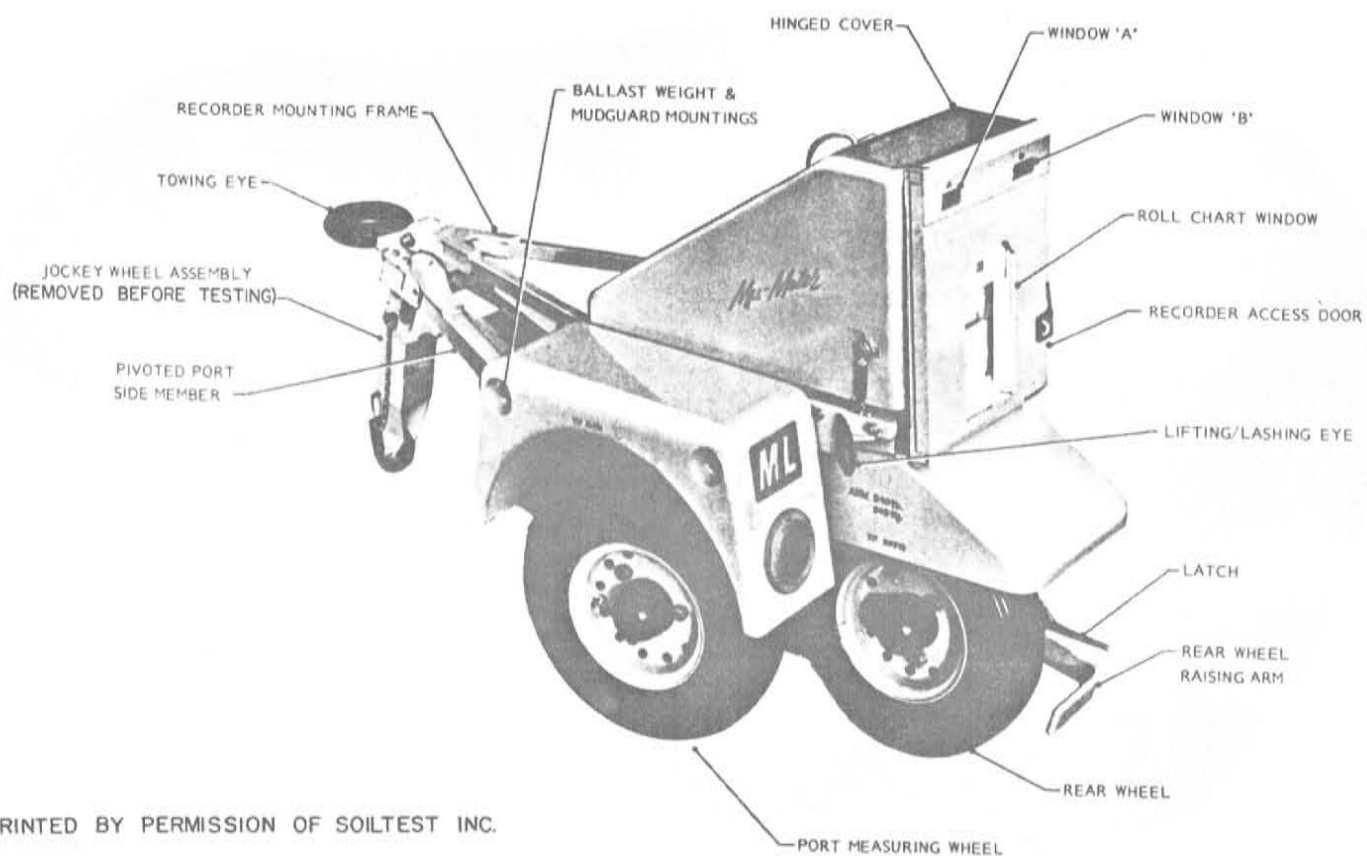
Figure 1

ORIGINAL MU-METER  
(UNMODIFIED)

The Mu-Meter is a continuous recording friction measuring trailer (Figure 1). It measures the side-force friction generated between the test surface and the two pneumatic tires which are set at a fixed toe-out angle of 7-1/2 degrees to the line of drag (Figure 2). Pulling the Mu-Meter over a surface

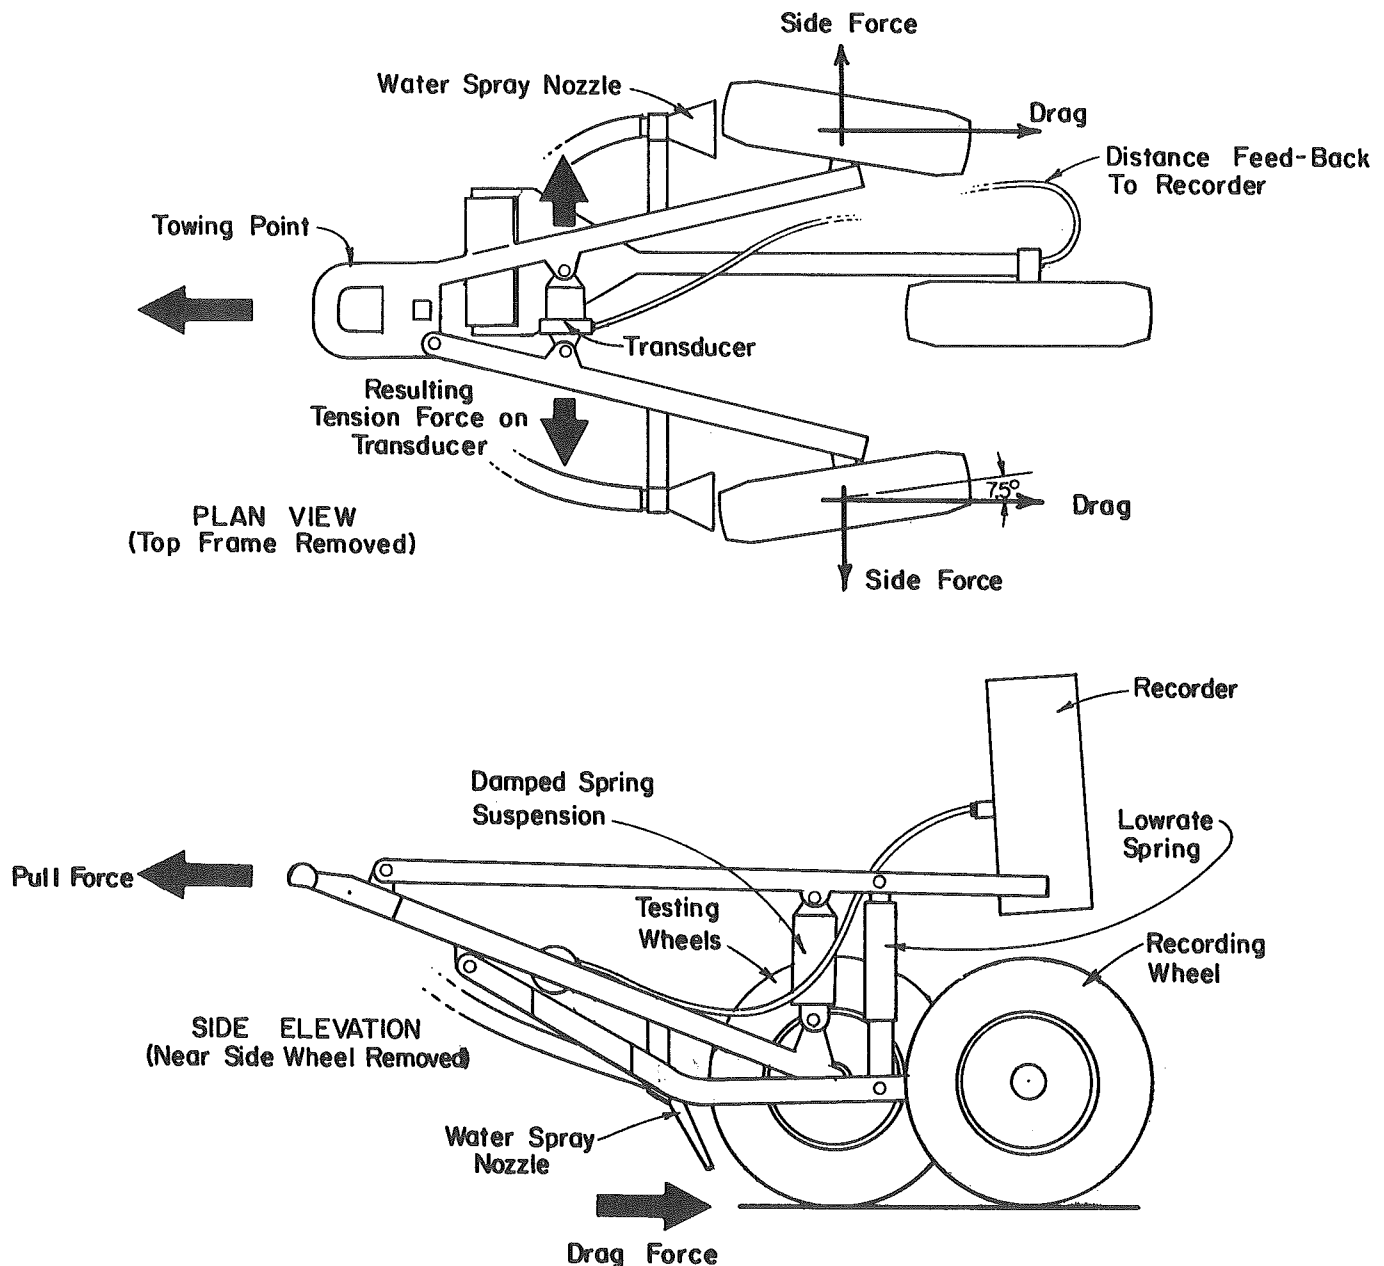
Figure 2

# MU-METER SCHEMATIC

Lower "A" frame (plan view) carries two friction test wheels on pivoted stub axles and king pins. Left wheel pivots from 7-1/2 degree toe-in to 7-1/2 degree toe-out position, which creates a total included angle of 15 degrees between the tires. The trailer is pulled with wheels yawed outward which produces a drag as the wheels continue to rotate. The transducer between the forks senses lateral movement of the hinged left hand fork pulled by side force. The center recording wheel rides on a separate arm and turns the flexible cable which drives the chart paper and two mechanical digital readouts in the recording unit.

produces a frictional force which is sensed by a transducer located in the apex of the trailer's A frame. The resulting hydraulic pressure is transmitted through a flexible line on the recorder's bourdon tube and recording mechanism (Figure 3). The recorder stylus makes a trace on the moving pressure-sensitive chart paper (Figure 4). The chart paper moves at a rate of one inch for every 450 feet of surface tested.

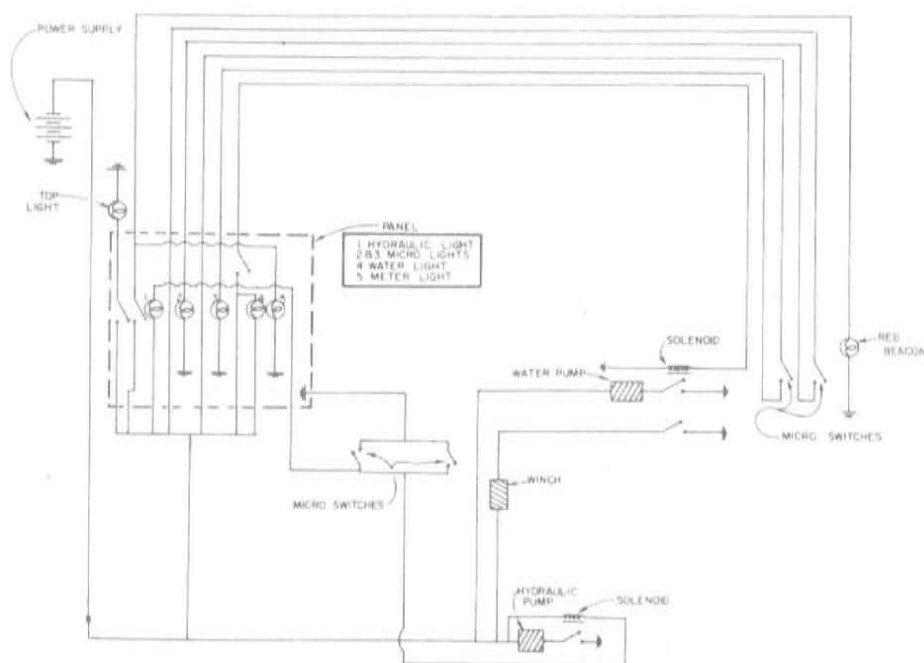
Figure 6

ELECTRICAL SCHEMATIC

A special electrical monitoring system was integrated into the hydraulic and water systems (Figure 6). The system included a number of micro switches which enabled the driver to determine the condition of all systems through a series of lights on the control panel. The system was very efficient and easy to install.

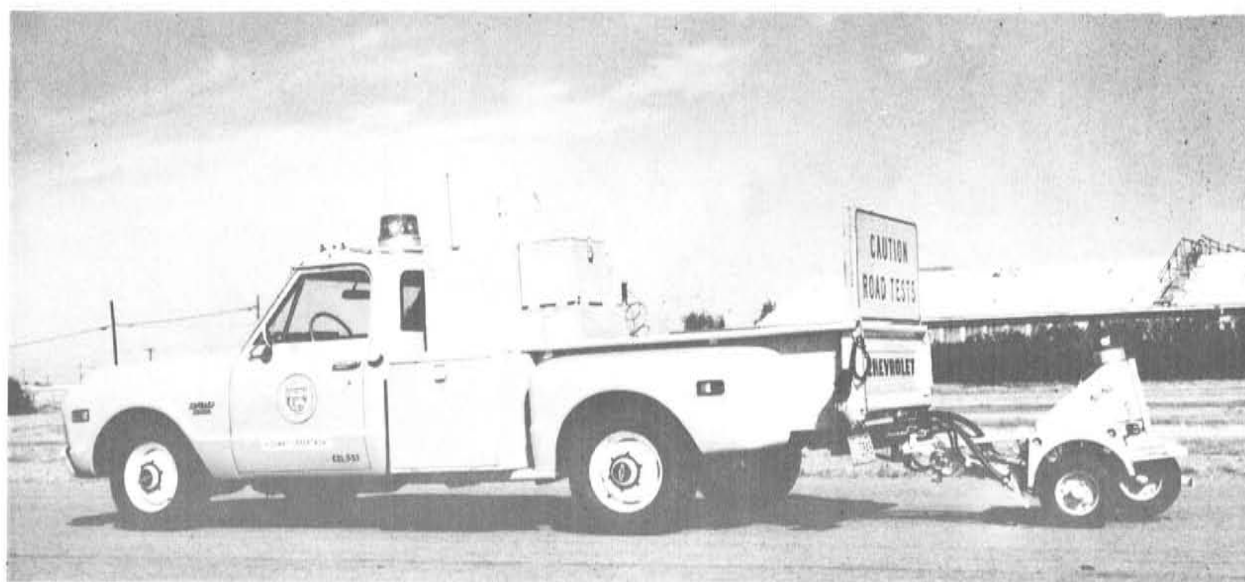
Figure 7

COMPLETE SURFACE FRICTION TEST UNIT

The towing vehicle, which has now become a part of the skid test unit, is a one-ton truck which carries a 300 gallon water supply and all of the support equipment (Figure 7).

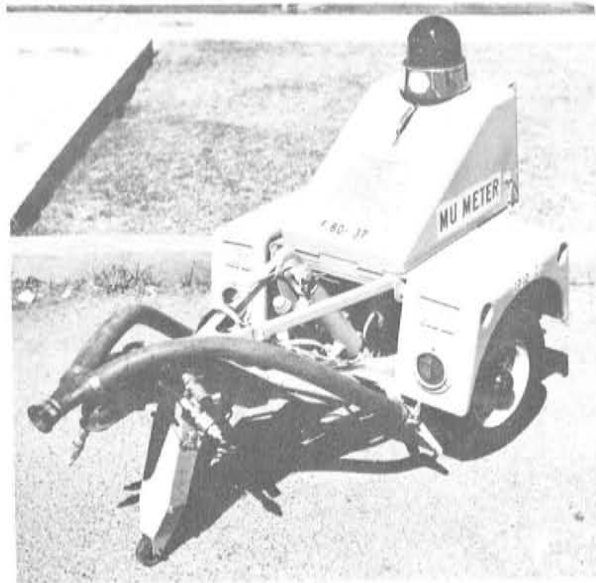
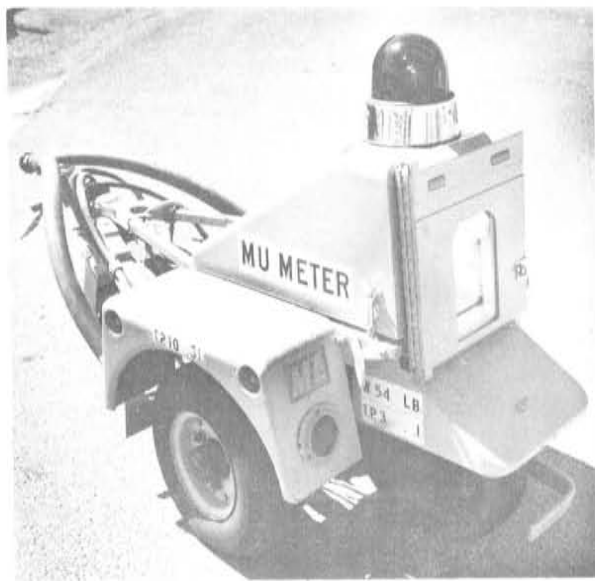
ARIZONA HIGHWAY DEPARTMENT'S  
MODIFIED MU-METER  
Figure 8

With the modifications of the Mu-Meter complete (Figure 8), the unit is highly maneuverable, and it is now possible to conduct numerous tests without stopping or interfering with traffic flow. Using this system, approximately 250 lane miles of highway can be tested in one eight-hour day. The normal test speed is 40 MPH with higher speeds possible between test sites. In addition, an automatic speed control on the truck insures the desired test speed.

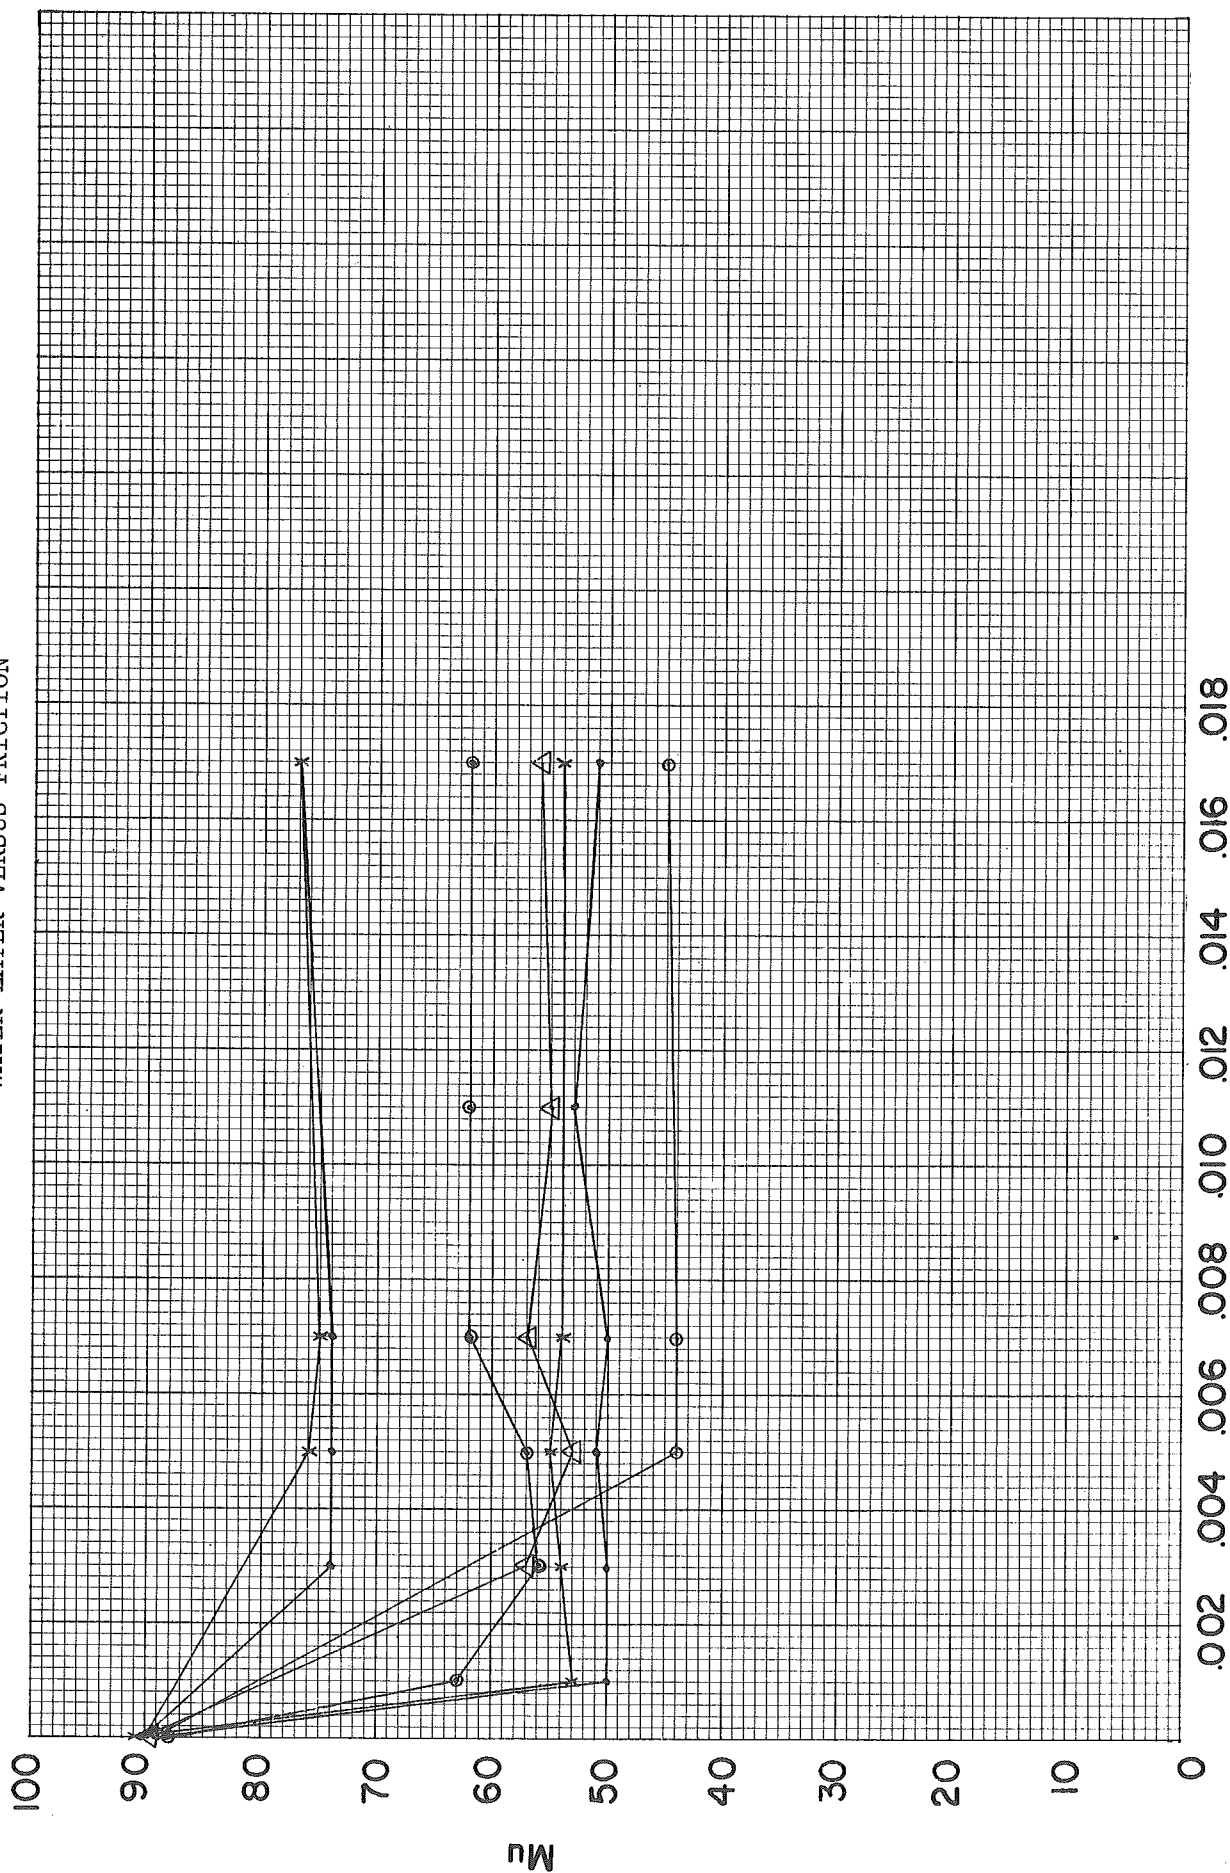
Figure 9  
WATER LAYER VERSUS FRICTION

Water Layer Thickness Under Test Tires at 40 M.P.H.

In an attempt to determine what a satisfactory water layer thickness under the Mu-Meter tires would be, a water regulation valve was added to the watering system. The water layer was adjusted from 0 to 0.018 inch of water (at 40 MPH) and tested at seven sites with different friction levels. In all cases, the minimum coefficient of friction was reached after the application of 0.005 inch of water and remained constant with increasing water levels. However, it is believed that if lesser water thickness had been used the results would have shown that 0.001 inch of water would have yielded the lowest coefficient of friction, as was seen in all of the cases in which the water thickness was reduced to this level (Figure 9).

It appears that the Mu-Meter's smooth tires need only an application of 0.001 inch of water to represent a wet roadway instead of the 0.02 inch required by the ASTM E249 ribbed tire. At the present time, however, the 0.018 inch water setting is being used for all testing and was the amount used for all the tests and correlations that are presented in this report.

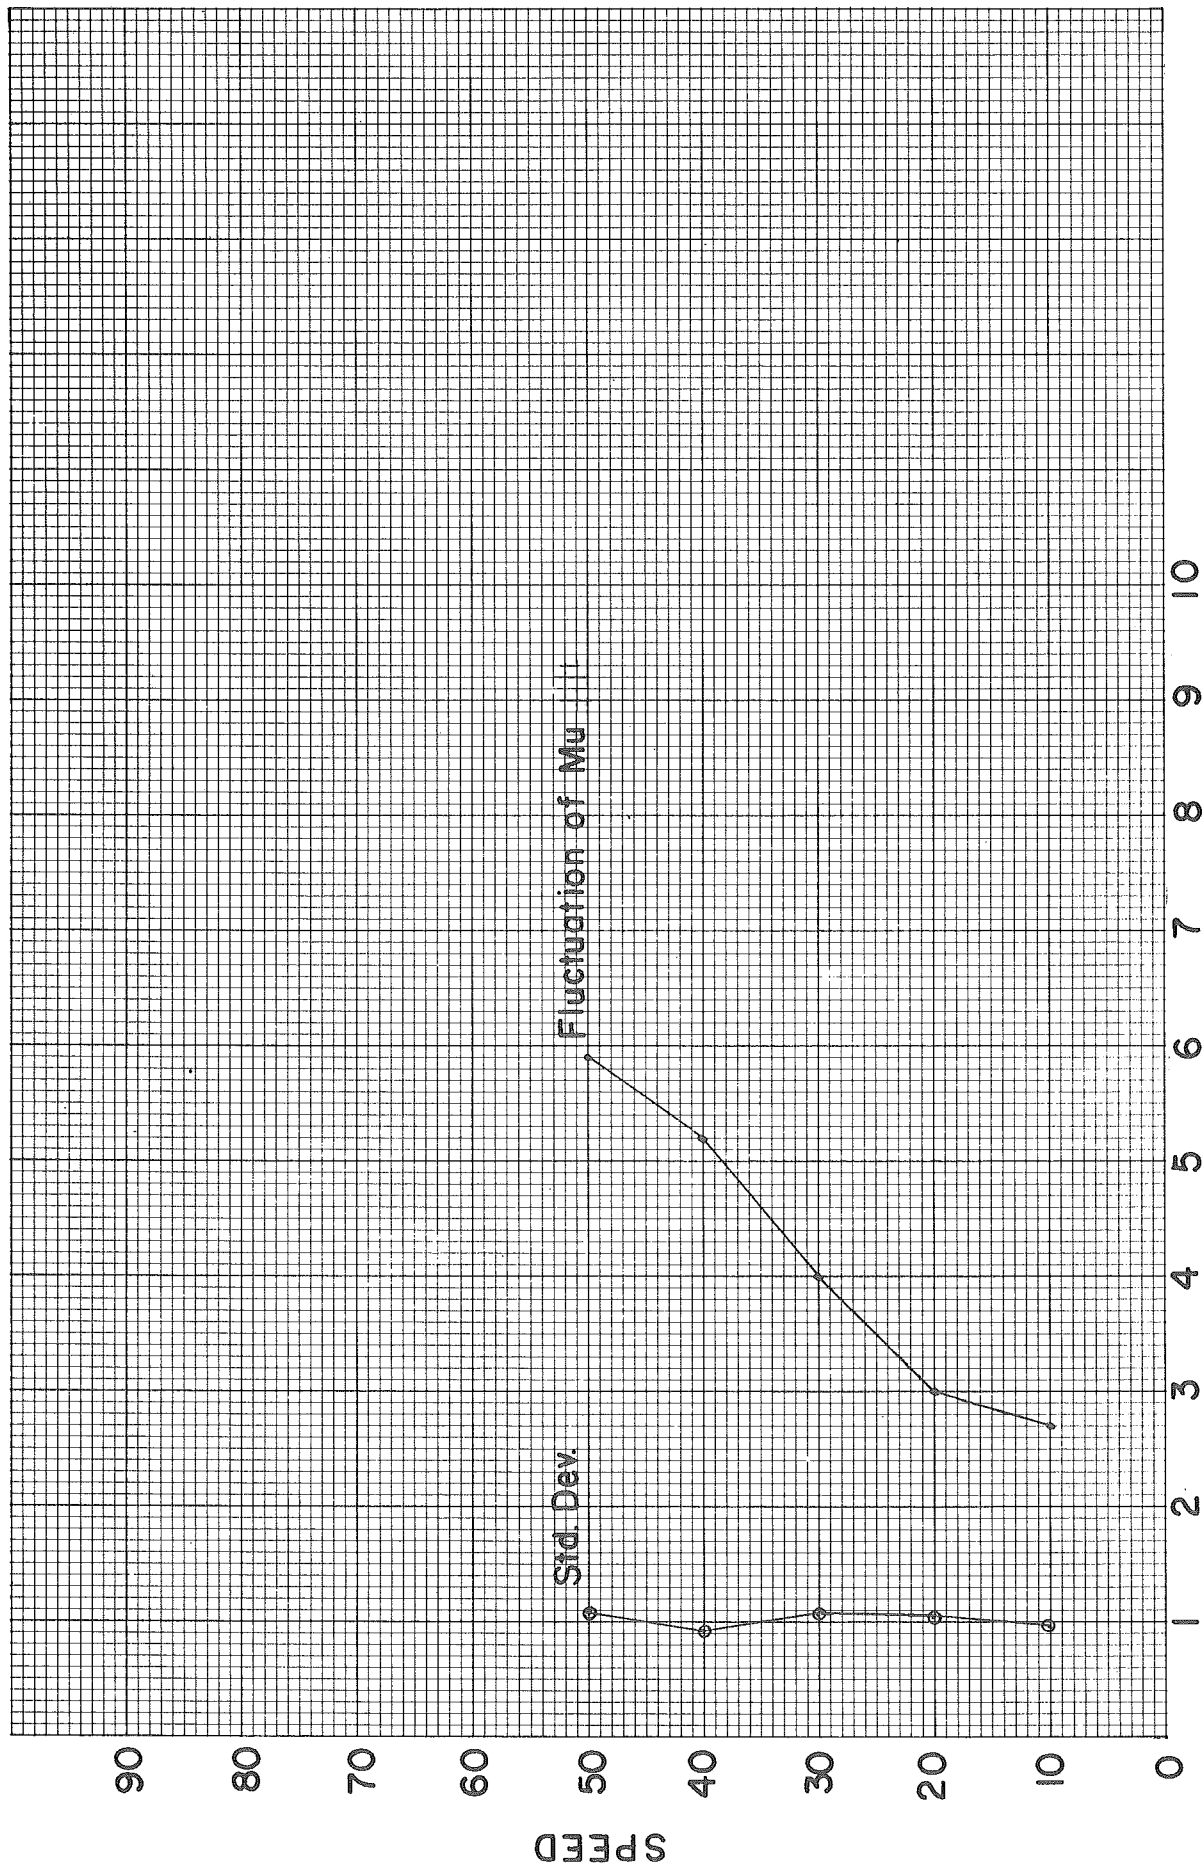
Figure 11  
SPEED VERSUS STANDARD DEVIATION

Standard Deviation and Fluctuation of Mu About the Mean

used to calculate all of the standard deviations for a series of passes. Thus, the standard deviations include an error in the averaging of the actual recorded friction. This method was used, however, because it is the method that would normally be used in field testing and inventory work. Even with the included interpretation error, the standard deviation for 29 different sites and six passes at each site was found to be 1.4 friction values at 40 MPH, which is very good for a friction measuring trailer. It was also found that, when all locations were averaged, the standard deviation was the same for six passes as it was for 12 passes at the same speed. A question arose as to whether the standard deviation might be related to the friction value at a particular site. For this reason, the average Mu-Meter reading for each site was compared to the standard deviation. It was concluded that the standard deviation was not significantly effected by the friction value of the pavement surface.

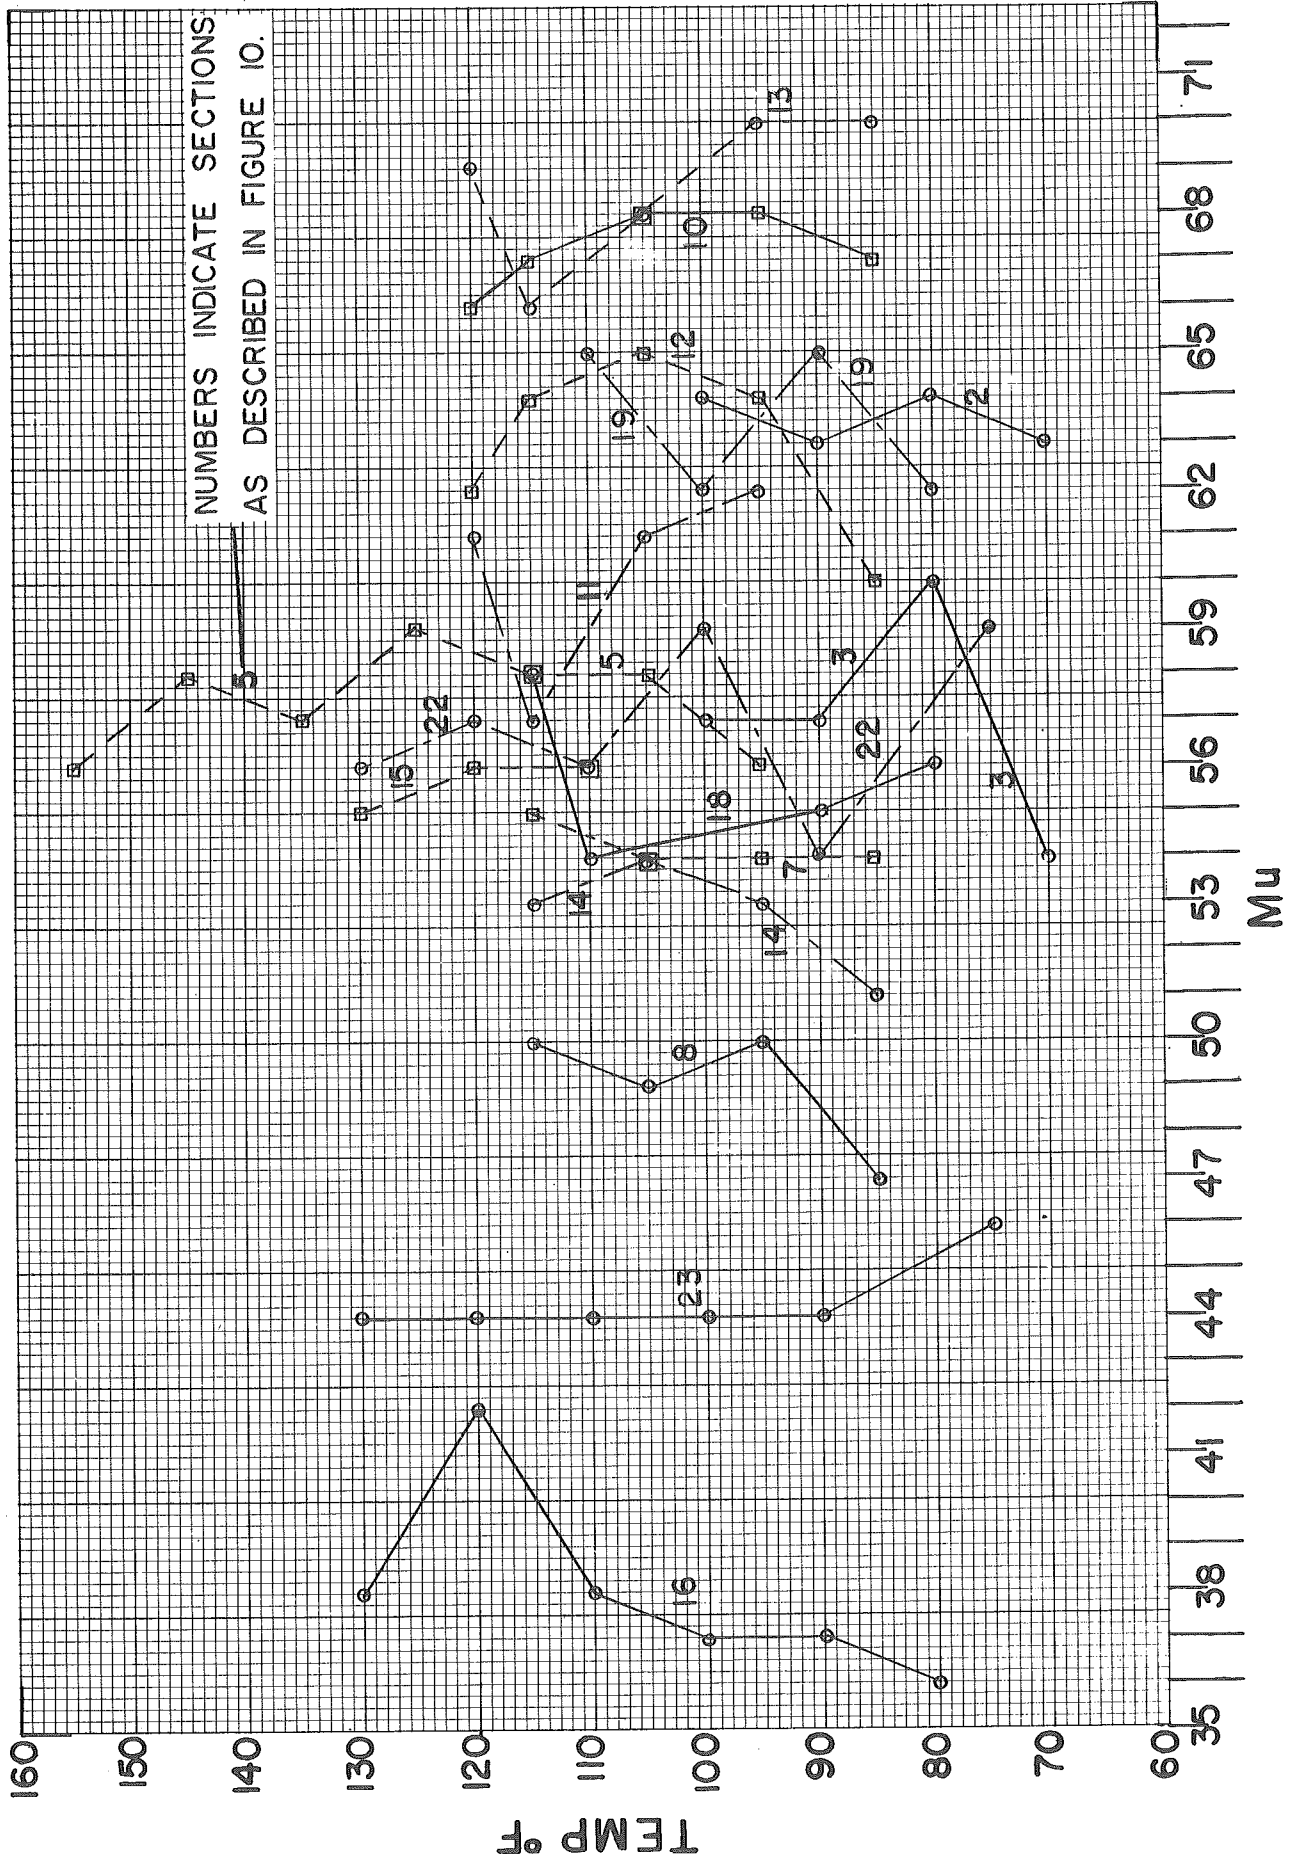
Figure 13

TEMPERATURE VERSUS FRICTION

A comparison of temperature versus friction was made, but a relationship could not be found (Figure 13). This is probably due to the non-destructive method of the Mu-Meter's test and the type of rubber used in its pneumatic tires.

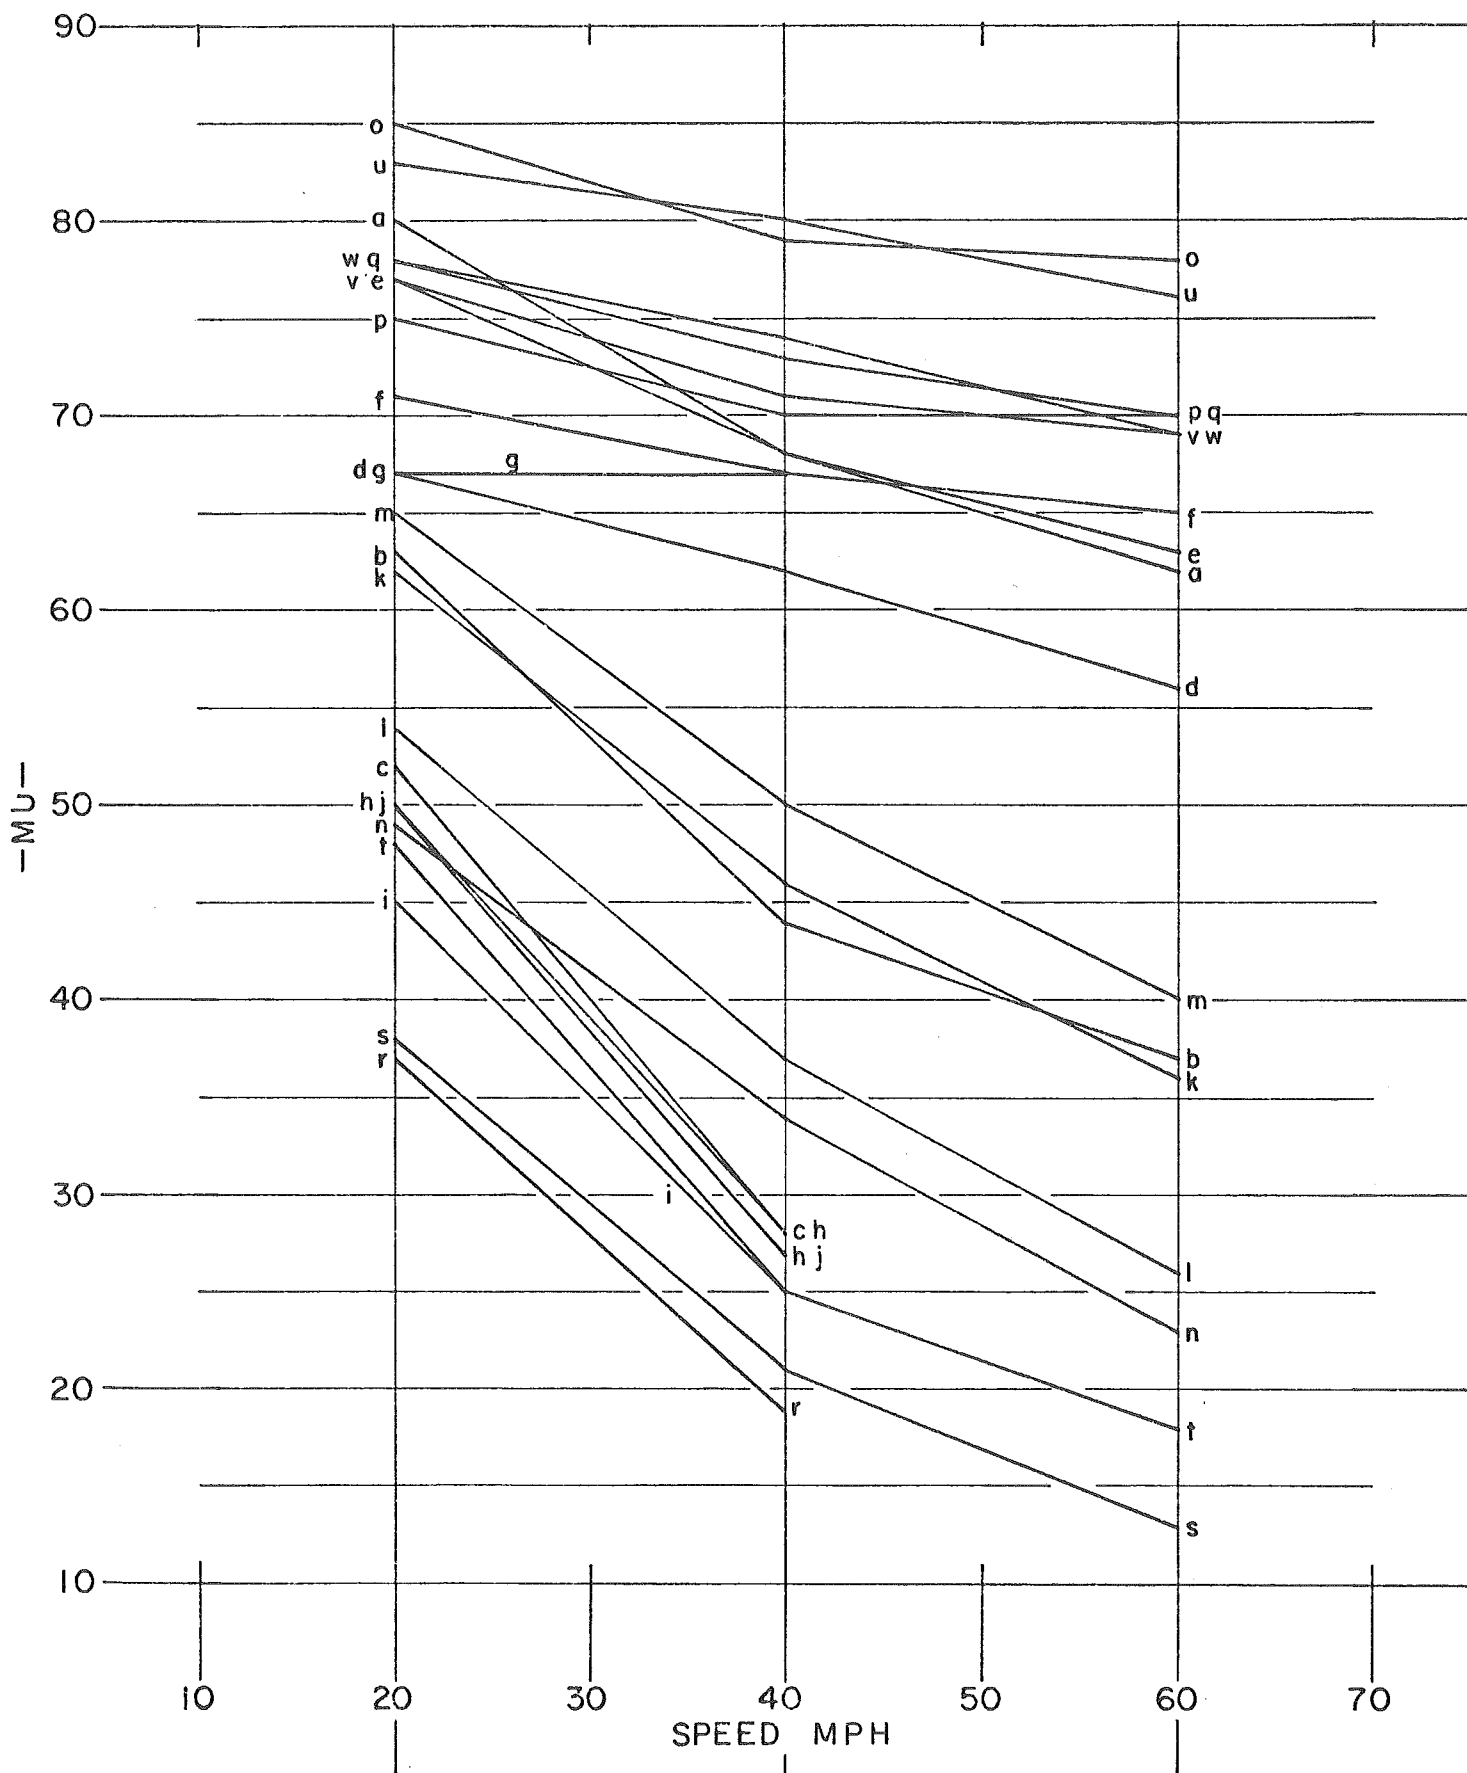
Figure 14

MU-METER  
SPEED VS. FRICTION GRADIENTS

When test speed was compared to friction, it was found that there was a strong correlation. With increasing speed, the coefficient of friction, as measured by the Mu-Meter, is reduced (Figure 14). Although the texture of the surface is reflected in the slope of the speed gradient, it can be assumed that there will be a decline of 4.0 friction numbers for every ten miles per hour increase in test speed. From these correlations, a prediction can be made of what the friction value would be at higher speeds if the friction value is ascertained at a lower speed (Figures 15, 16, 17, and 18).

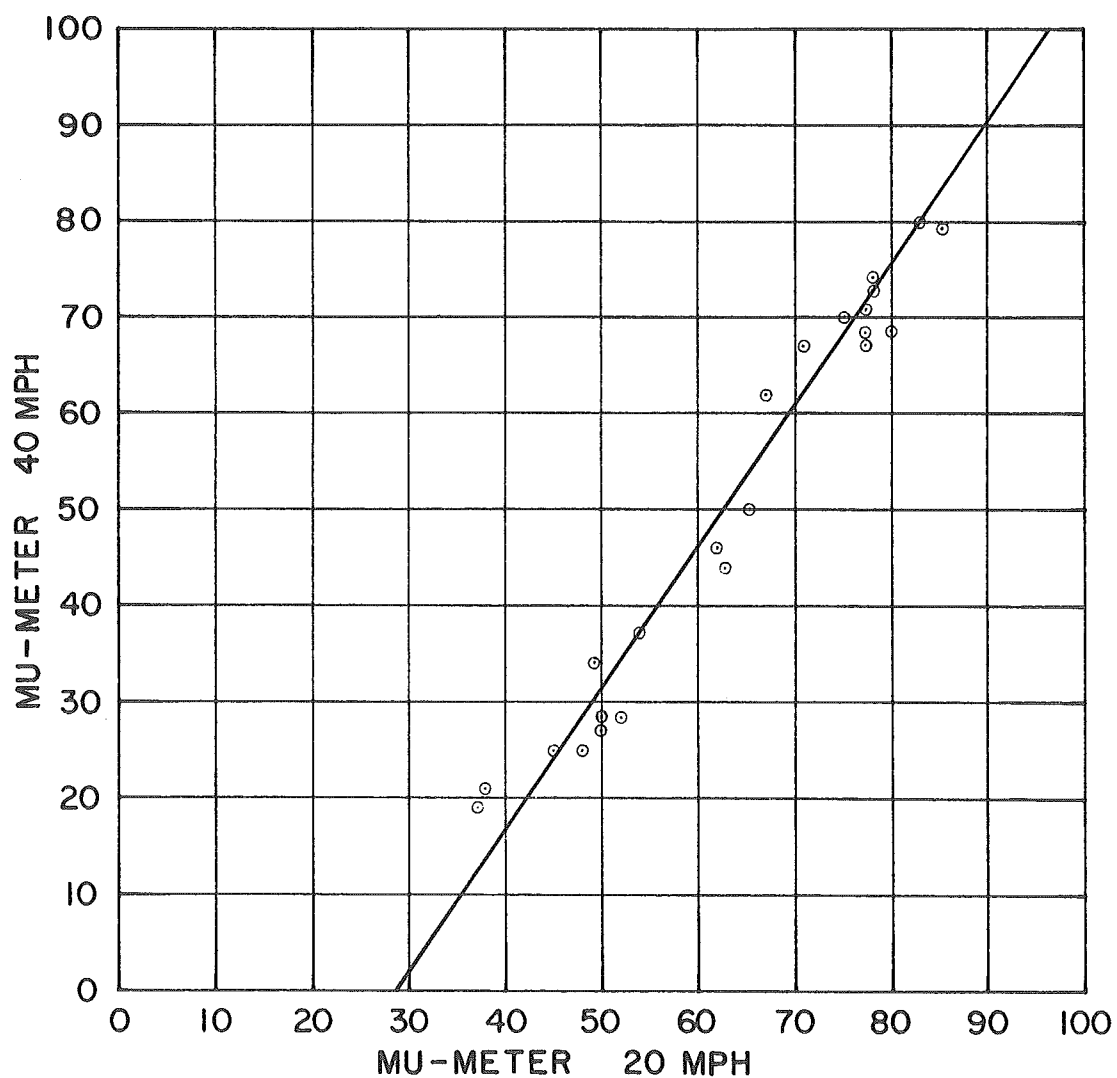
Figure 15

$Mu_{20}$  versus  $Mu_{40}$

Number of cases = 23  
 $Mu_{20} = 28.8912 + 0.67627 (Mu_{40})$   
Correlation coefficient = 0.97515  
Standard error = 3.365

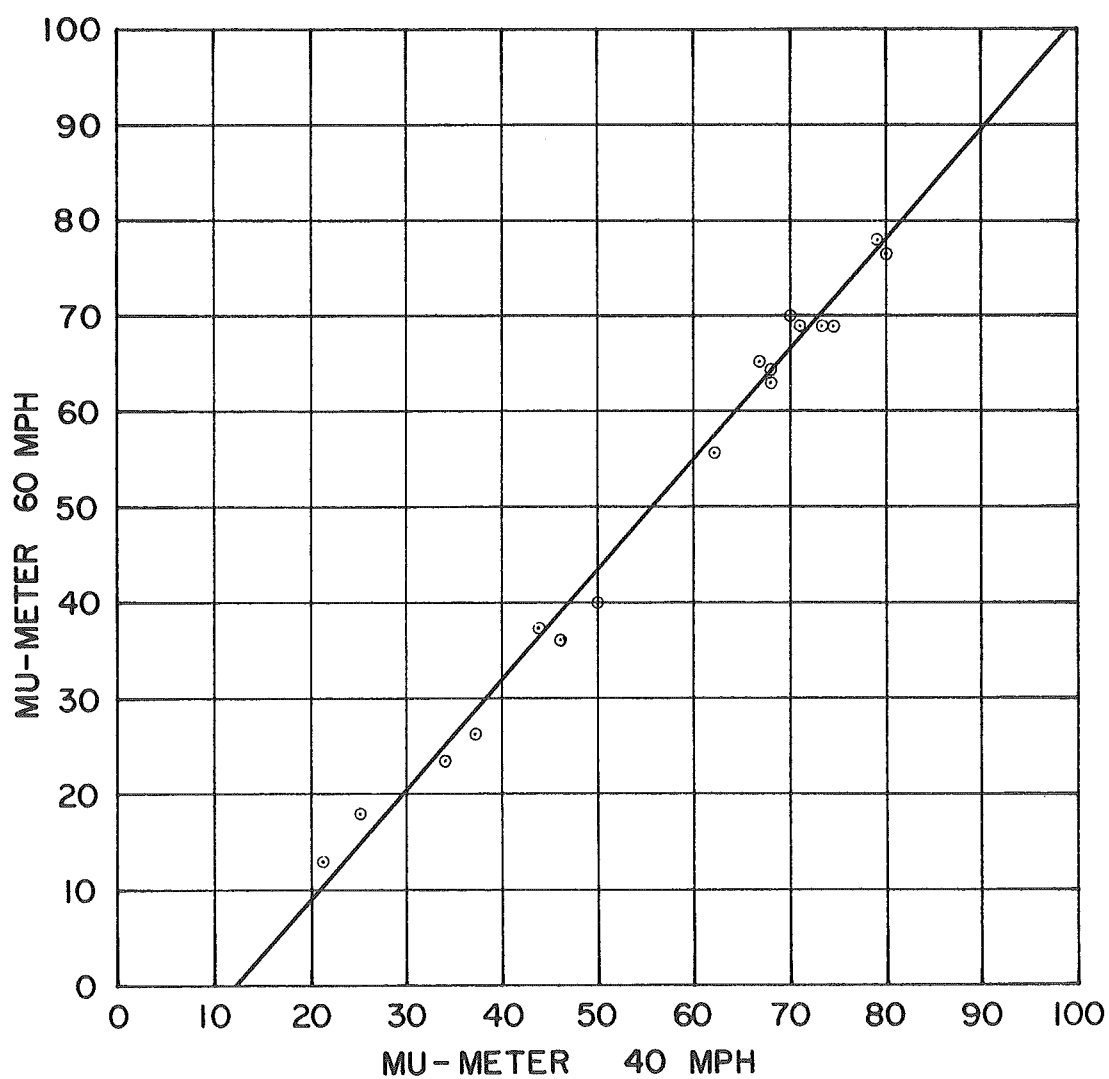
Figure 16

Mu<sub>40</sub> versus Mu<sub>60</sub>

Number of cases = 17

Mu<sub>40</sub> = 12.4279 + 0.86895 (Mu<sub>60</sub>)

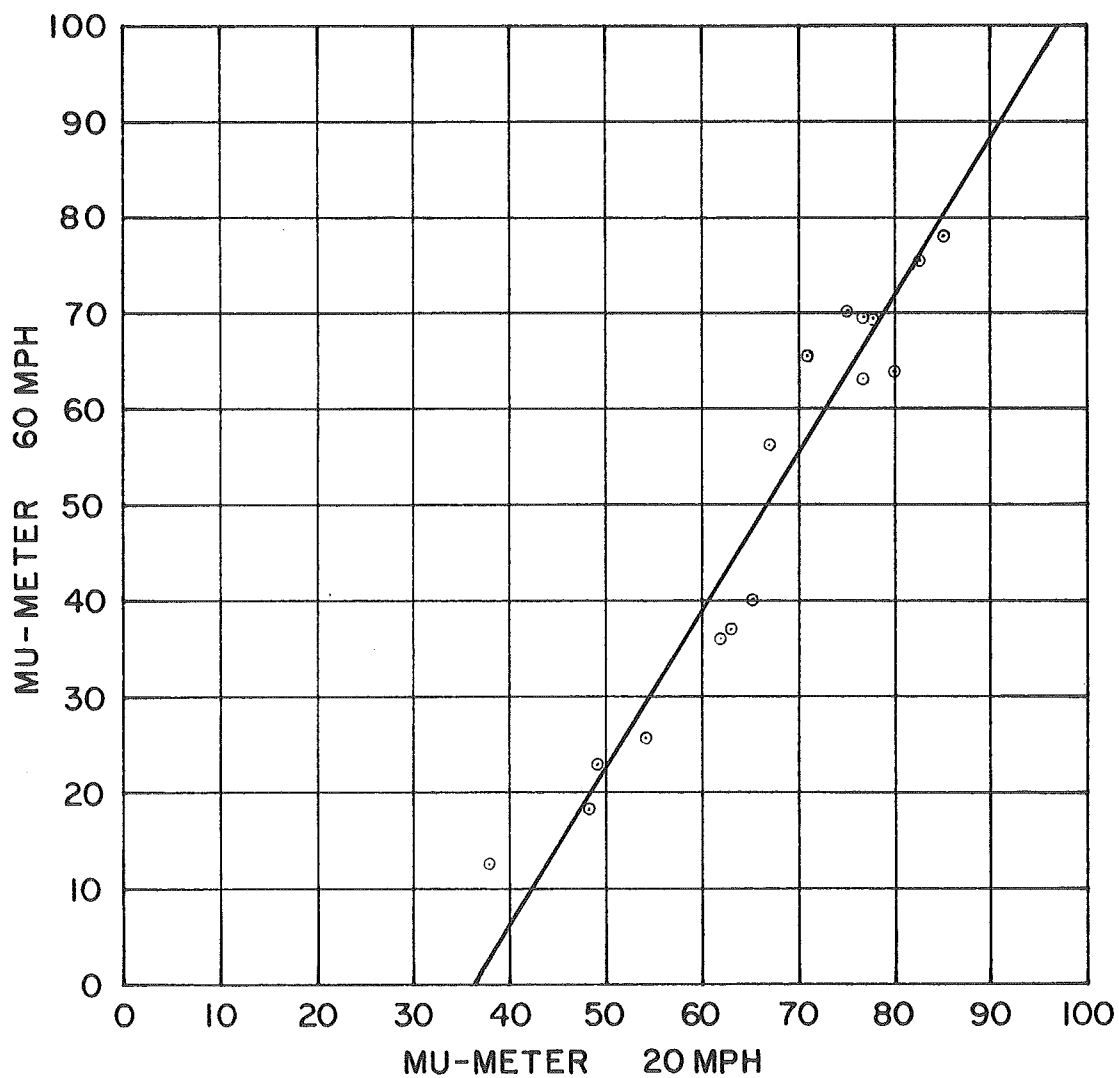
Figure 17

$Mu_{20}$  versus  $Mu_{60}$

Number of cases = 17  
 $Mu_{20} = 36.573 + 0.60580 (Mu_{60})$   
 Correlation coefficient = 0.97013  
 Standard error = 3.433

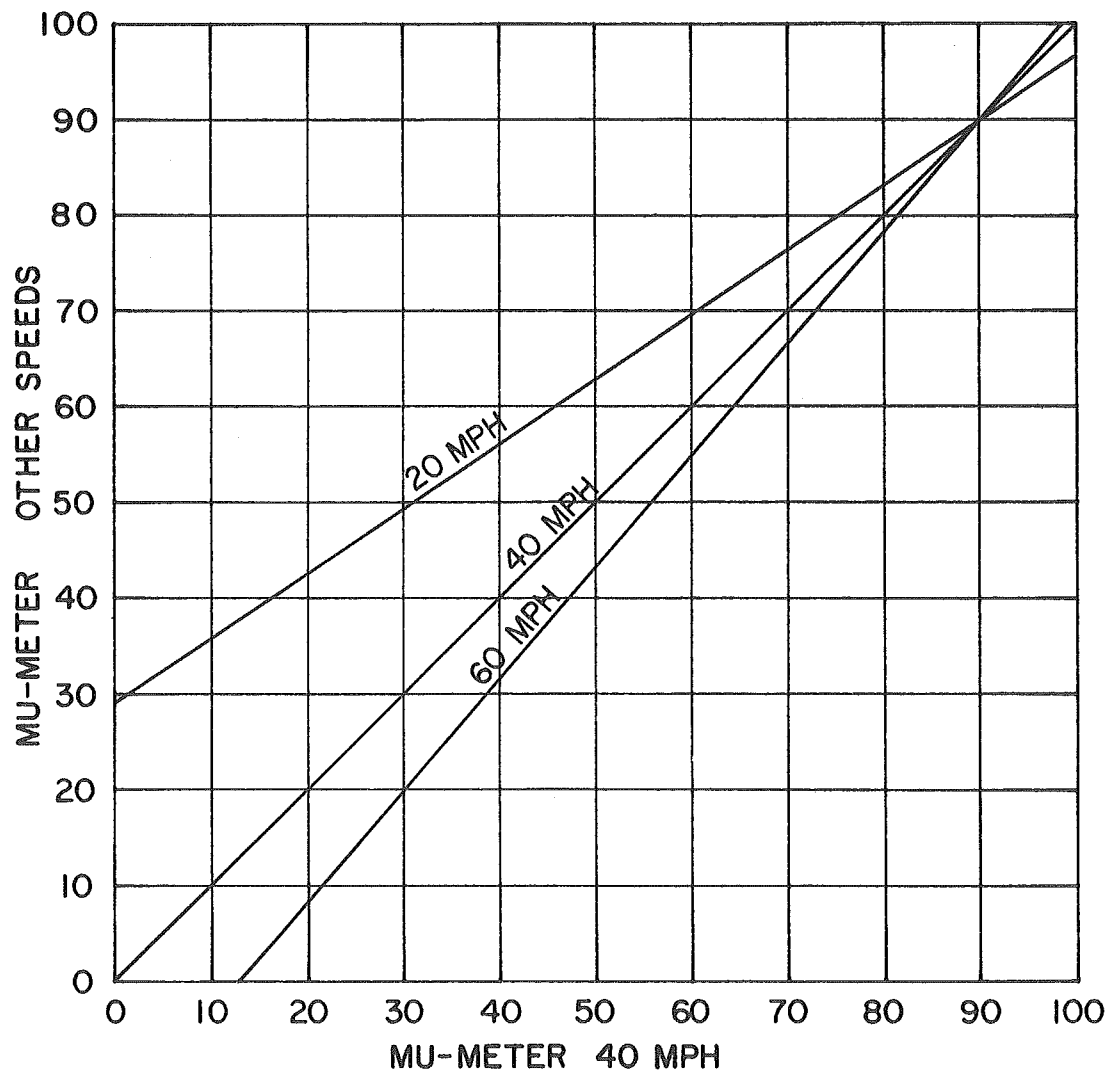
Figure 18

Mu versus Other Speeds  
40

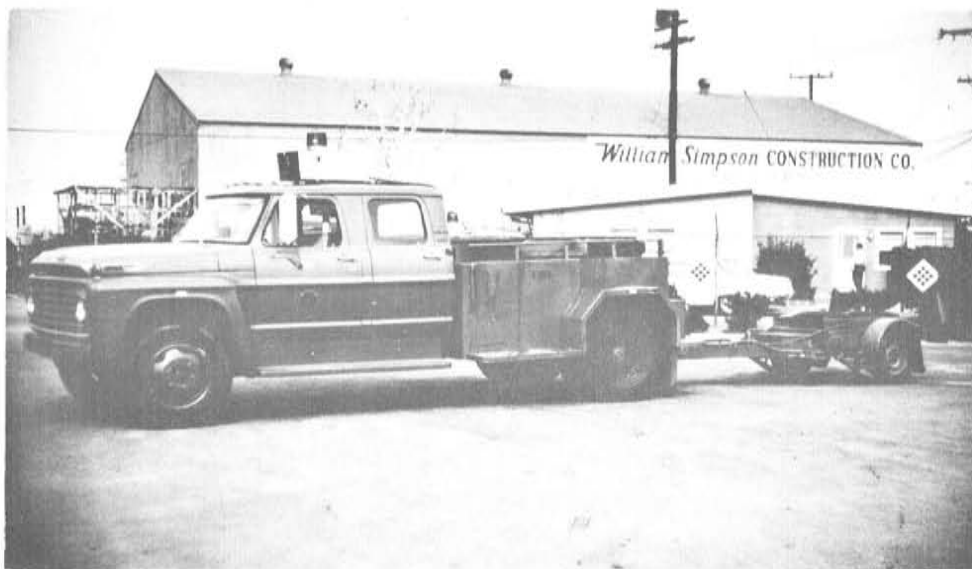
EXAMPLE OF A LOCKED WHEEL SKID TRAILER  
Figure 19

1. locked wheel trailers (Figure 19),
2. stopping distance cars (Figure 20), and
3. pendulum testers such as the British Portable Tester (BPT) (Figure 21).

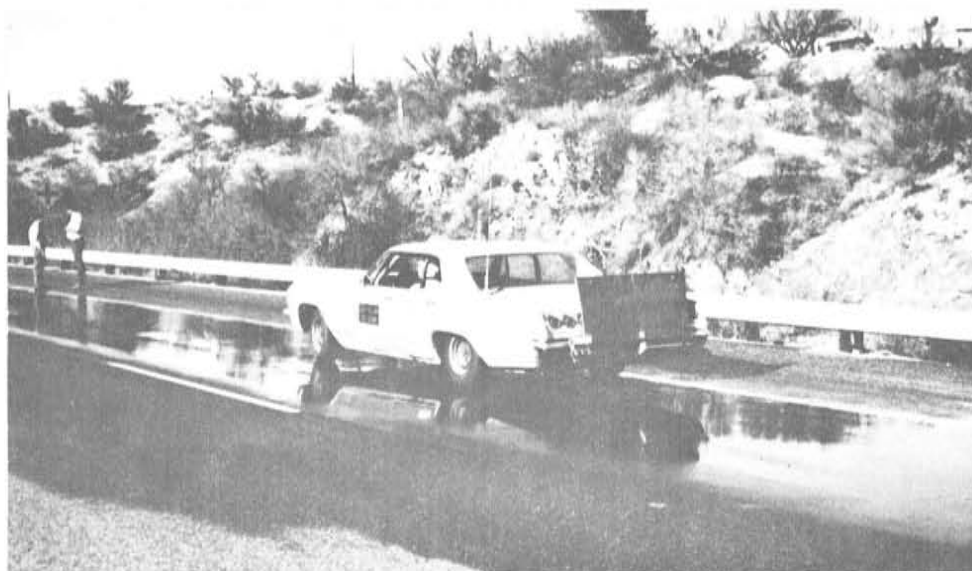
ARIZONA HIGHWAY DEPARTMENT'S SKID CAR  
Figure 20

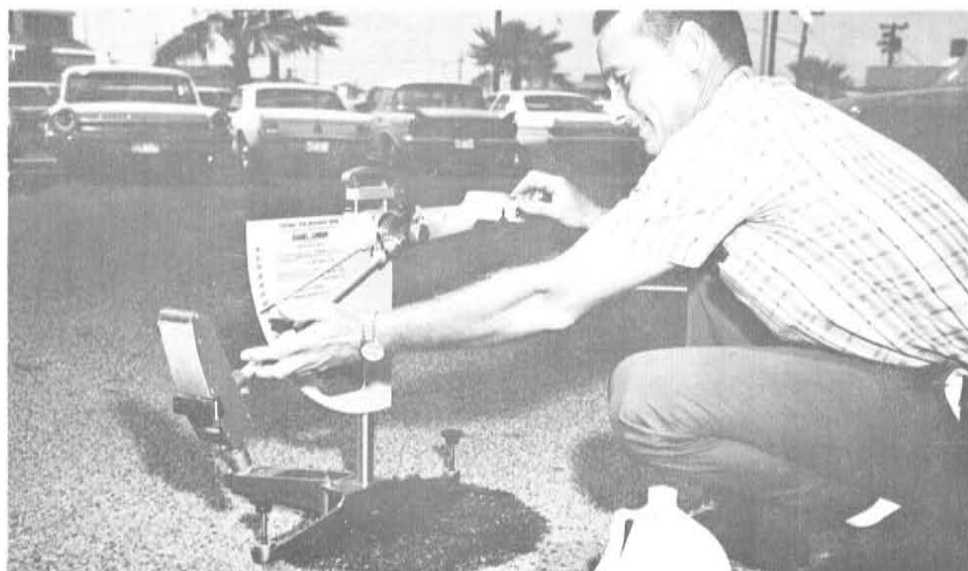
BRITISH PORTABLE TESTER  
Figure 21

3. After the series was completed, the BPT was used to test the surface at three locations in the wheelpaths using the recommended BPT test method.
